# Another Cable Strike at Thornton

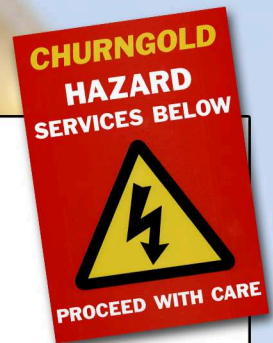
Our site team at Thornton had another lucky escape when they hit an electric cable that was not protected with any tape or it's location confirmed by the use of Churngold Services Boards.

The cable had been backfilled the previous day so its was believed that the position was known by all our team but clearly this wasn't the case. If tape or services boards had been used the chances of hitting this cable could have been greatly reduced and most likely the incident would not have happened.

Once the cable was hit, the team made the site safe, but there seems to be confusion as to what actually happened running up to the cable strike. A thorough examination was not undertaken straightaway when everyone had the incident fresh in their minds. There were even conflicting reports as to the use of a CAT scan prior to digging, which brought into question our supervisor of the works.

Remember - Always obtain a PERMIT TO DIG from the Principle Contractor and CAT scan the ground before excavating anywhere. Always install protection tape when burying any services, even temporary ones, and always maintain the Churngold Services Boards in place to show where the services are and always hand dig only within 500mm of any live services.
